Richland Community Library Exterior Assessment and Repair Plan

Proposal No.: P25051

Date: May 22, 2025

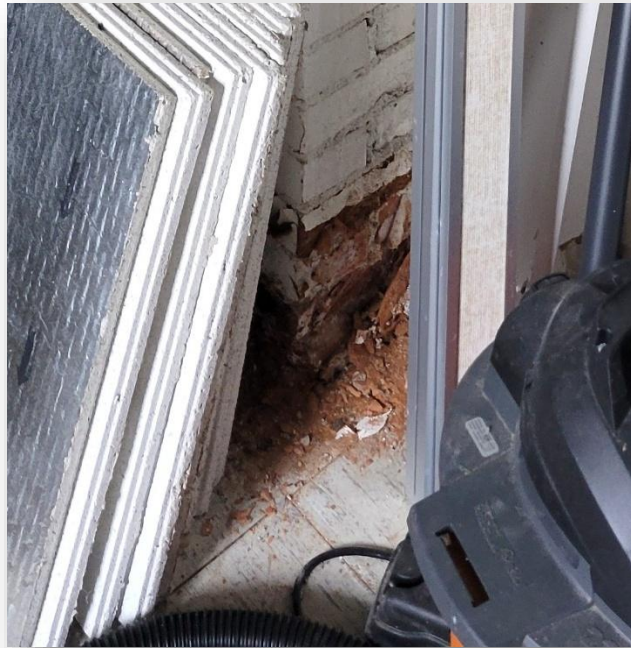
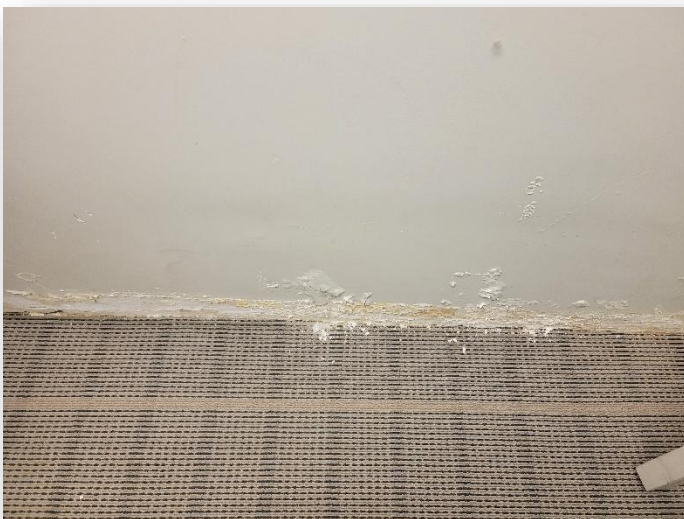
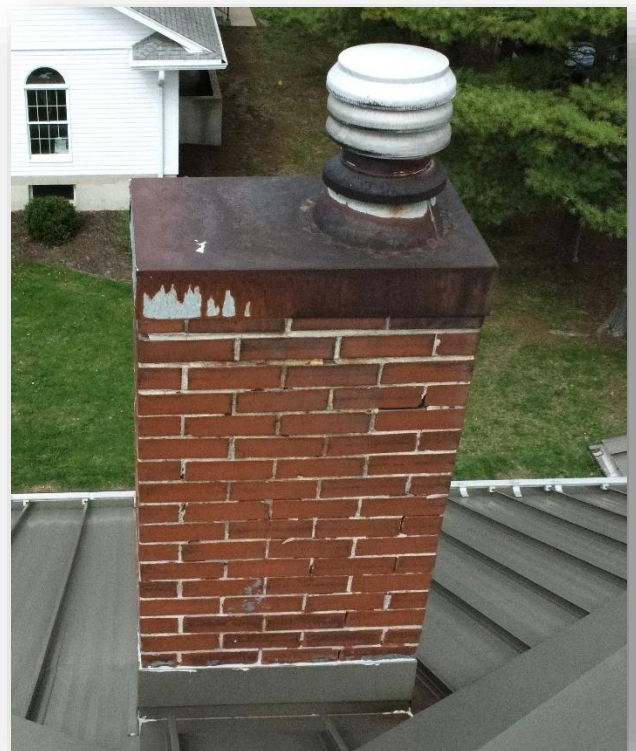
- **Original Chimney:** The original chimney has been leaking for quite some time. As can be seen in the attached photographs there is heavy deterioration damage at the base of the chimney and the basement of the library along with damage to drywall and finishes that are framed alongside the chimney. The upper portion of the chimney that protrudes from the newer metal roof requires extensive mortar replacement, brick replacement, and the current cap is heavily rusted with failing sealants around the flashing. A repair scheme for this area would be to clean and repaint the cap to eliminate the rust damage and create a surface that sealant will bond to. This will allow us to repair any pin holes or leaks in the cap. Replacement of all failed mortar joints on the chimney and any cracked or displaced brick will be replaced or re-laid along with the replacement of sealants on the roof terminations and counter flashings that may no longer be functioning to prevent water infiltration.

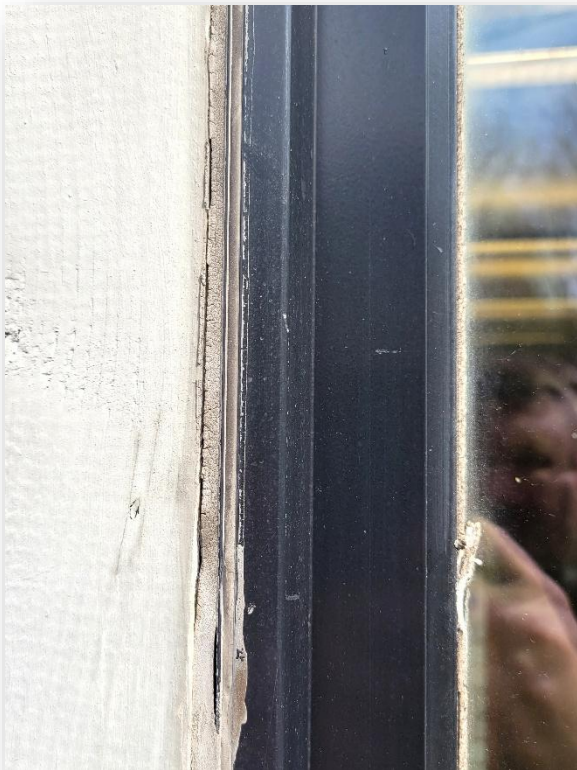
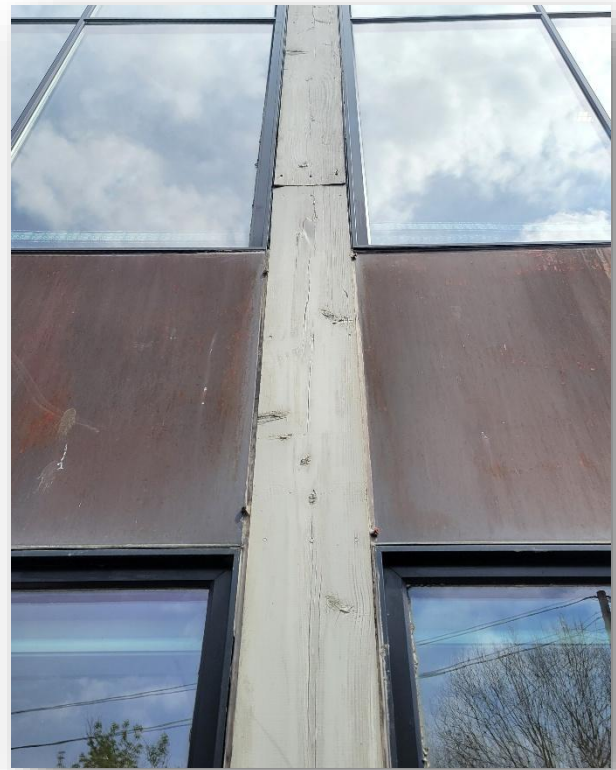
- **Large Window Sections on North and South of New Building:** The original sealant in the window sections is urethane and has surpassed its service life. It is shrinking and debonding from the window trims and perimeters along with glass seal and frame to wood trim seal. These open as they can no longer stretch and account for movement or simply did not bond properly to the wood surface, they allow moisture in the window perimeter. As evidence of moisture damage at all the wood sills and trim on the interior of the building. Both the north and south sections require all existing sealants in the systems and trims replaced with a silicone based sealant that will accept this level of movement and remain intact. The wood trim pieces in between the window sections are of particular concern due to the lack of bond that most sealants have with wood over time. These pieces will be removed, the flashing detail will be evaluated to direct any water out that enters behind the wood in the future, and the wood will be replaced and a new sealant joint installed. It will be discussed at the time of replacement if the new wood pieces should or should not be wrapped in aluminum or be made of a plastic product that allows an advantage to adhering sealant.

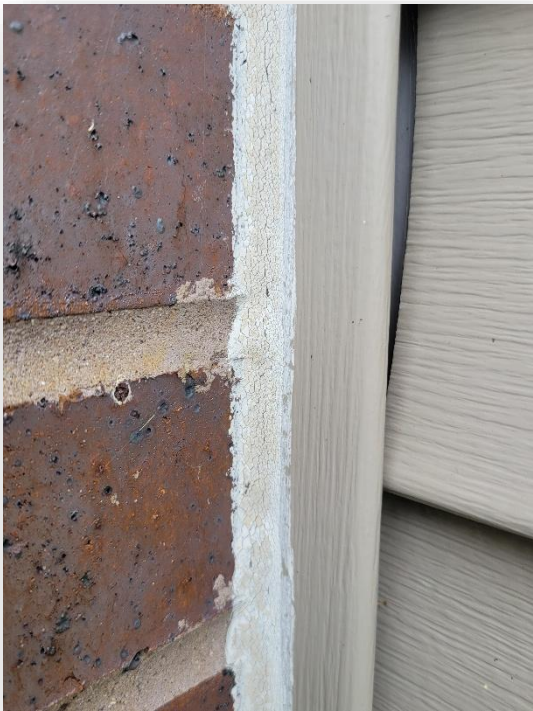
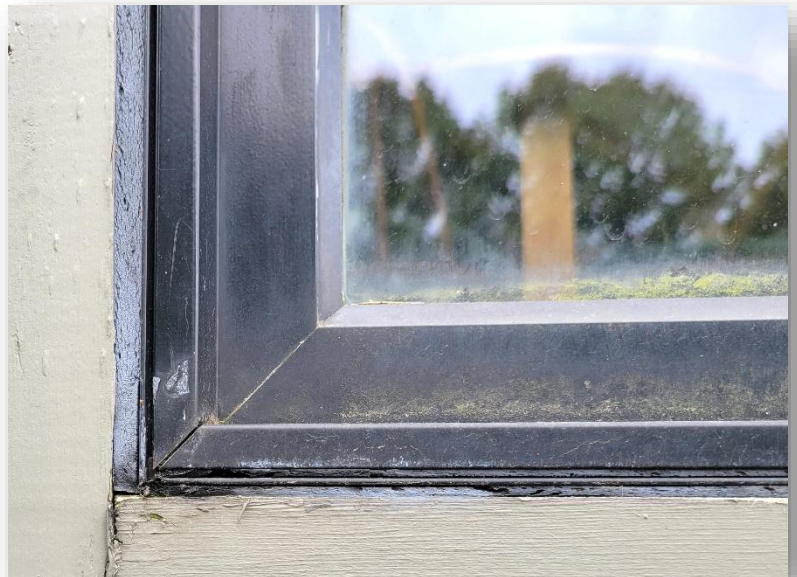
- **Urethane Sealants:** All the existing building penetrations on the new structure windows and doors have been terminated with a urethane sealant that is susceptible to UV deterioration and has a service life of 7 – 10 years. This sealant is weather checked, ripped open, debonding, and no longer creates an adequate seal to stop the infiltration of water. All the currently failing urethane sealant on the additions and newer structure will be removed and replaced with a silicone sealant utilizing the following procedures.

1. Remove existing failed sealant via grinding and oscillating knife.
 2. Clean all joints of dirt, dust, and debris.
 3. Install bond breaker, or properly gauged backing rod to prevent three-sided adhesion.

4. Install a one-part neutral cure silicone sealant.
 5. Dry tool sealant to assure two-sided adhesion and to avoid the premature failures associated with wet slicking.

6. Color of sealant will match the existing.

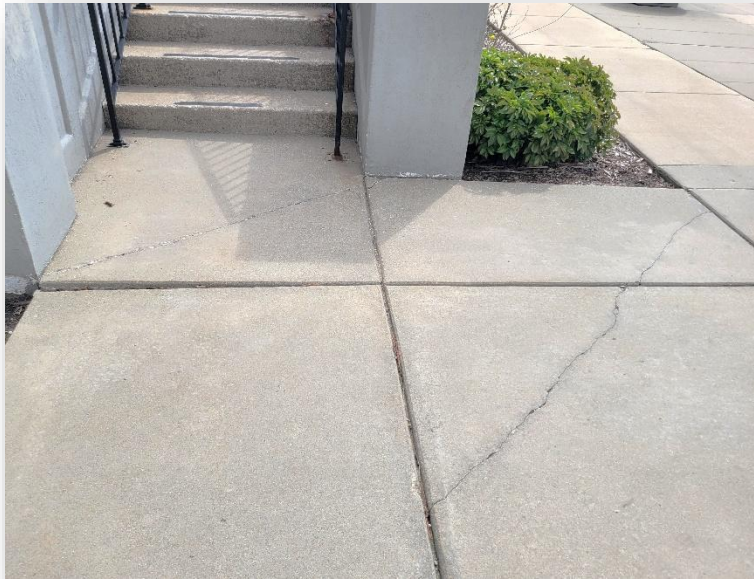
- **Sidewalk Repair:** At the left stair of the main entrance four panels of the sidewalk approach have either cracked or sunk in to a point where tripping hazards have been created. As this is a public entrance we highly suggest the removal and replacement of these four panels. Along with this we will remove and compact the base material to create a stable substrate for the new sidewalk to be supported. Once the sidewalk is poured back the surface will be exposed by washing off the concrete paste topping. This will provide an aged look to the new sections of the sidewalk, so they blend in with the surrounding sidewalk.

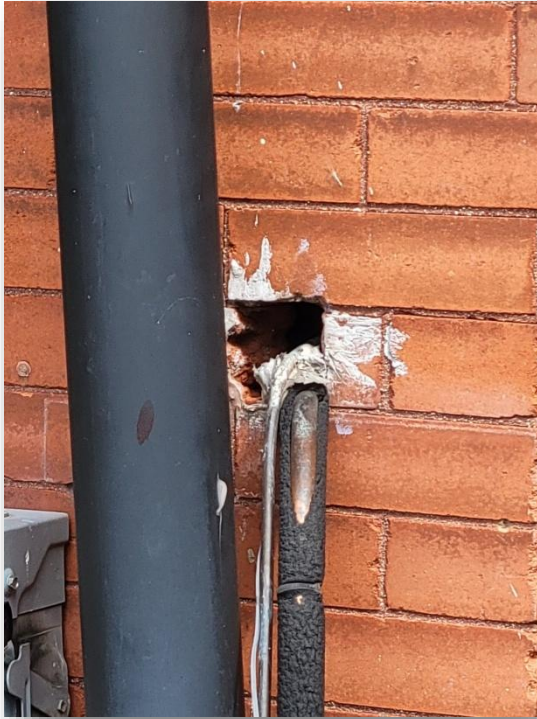
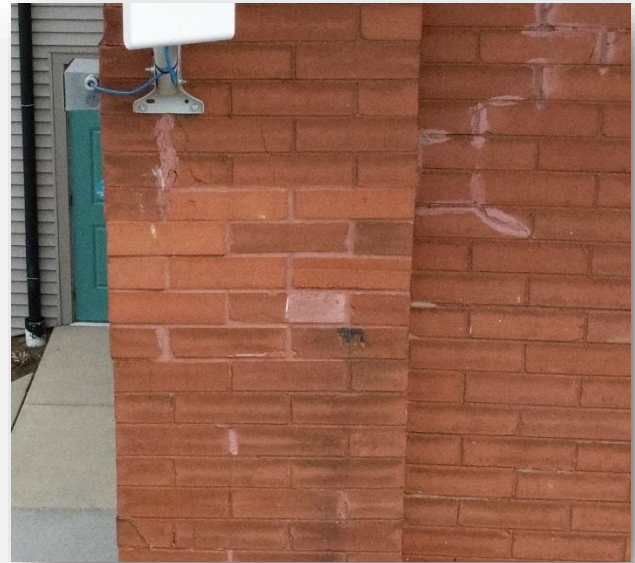
- **Brick Replacement:** Due to the age of the brick on the original structure the brick is very soft and ductile. There has been repointing and replacement performed over the years with a harder mortar or harder brick and by nature they do not move the same. All failed mortar joints on the original structure will be removed and replaced with an aesthetically matching mortar, but most importantly a mortar that matches in compressive strength and porosity, so it can breathe and move like the original. All broken brick will be removed and replaced with an as closely as possible matching brick.

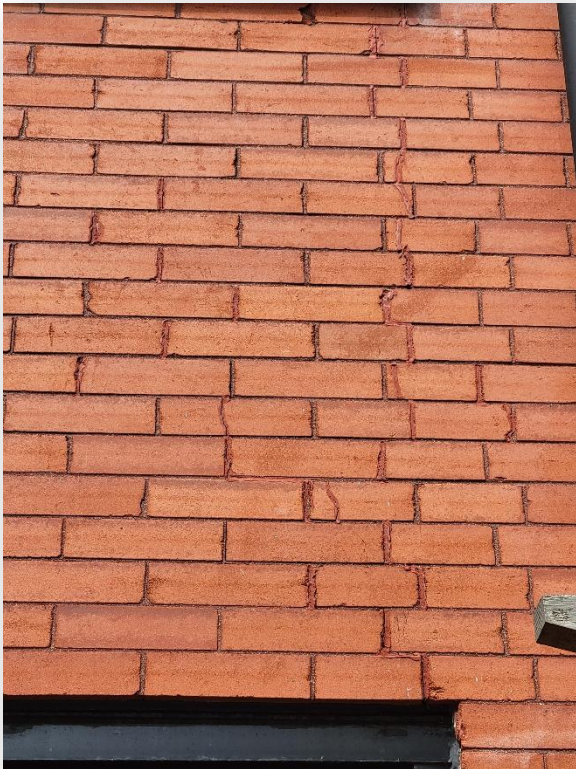
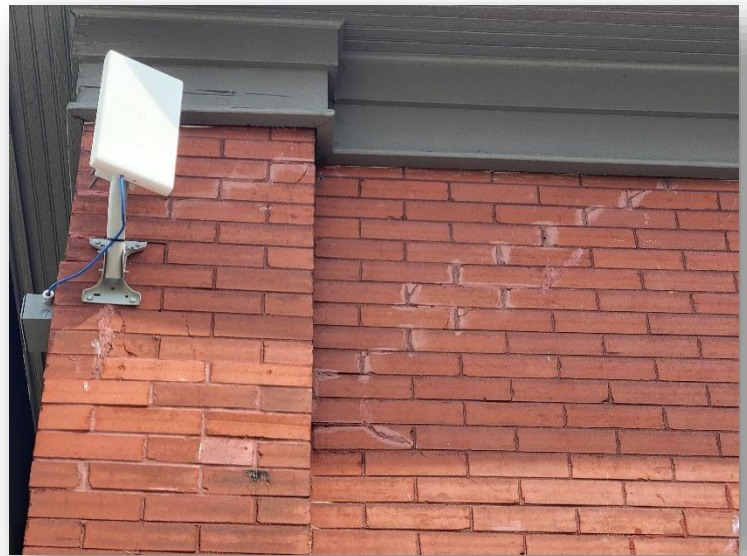
- **Brick Repointing:** All mortar joints that are no longer functioning to properly bond together brick and masonry units and resist the ingress of water will be replaced, along with any joints that have heavily eroded away from their original surface. Building Restoration, Inc. will not be removing and replacing previous inadequate repairs unless they have failed. The following steps to proper re-pointing will be followed:

1. Mortar matching will be achieved via matching our pre-made biscuits, followed by an onsite match to be verified by you, prior to repointing.
 2. The mix design will be a lime putty-based mortar with matching aggregate to achieve national park standards of proper bond and same or lower compressive strength as the matching mortar.

3. Removal of deteriorated mortar (a minimum depth of two times the width of mortar joint) will follow the current OSHA standard for silica dust control when performing this work.

4. Removal of debris in the joint will be via brushing, vacuuming, or water flushing.
 5. Close examination will determine the extent of deterioration in the joint and surrounding area.

6. Rework the joint, as necessary.
 7. Air blast to remove debris in the joint.
 8. Water-soak the substrate.
 9. Pre-wet to reduce the amount of initial dehydration of the mortar that is about to be replaced.

10. Deliver mortar to the prepared joint. Several layers may be required to fill the joint flush with the outer surface of the masonry.
 11. Strike back (tooling the joint to match the existing historic joint).

12. Wait for the mortar to set until it is ready to be compacted.

13. Dry brush compact the joints to allow for further development of bond to original remaining mortar and substrate.
14. Allow for adequate cure of the new mortar.
15. Pre-wet to saturate the substrate in preparation for the last step.
16. Weathering wash to match the old and new masonry.

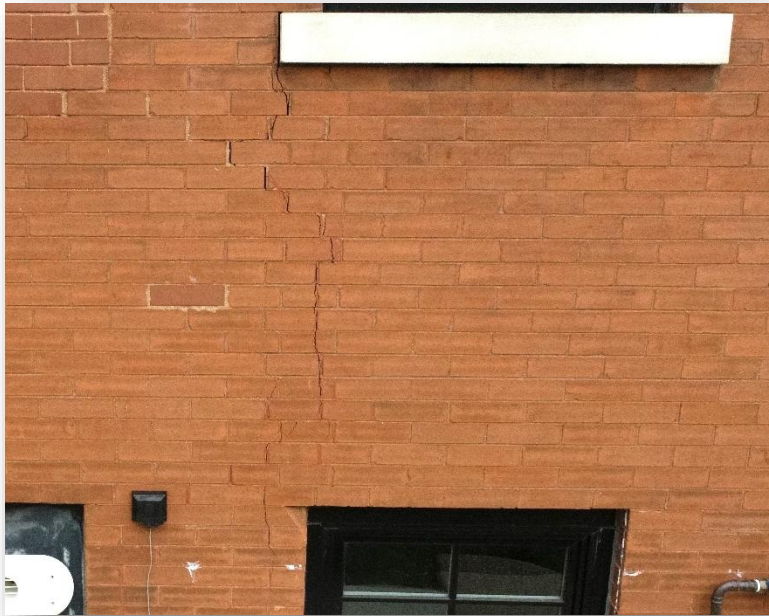
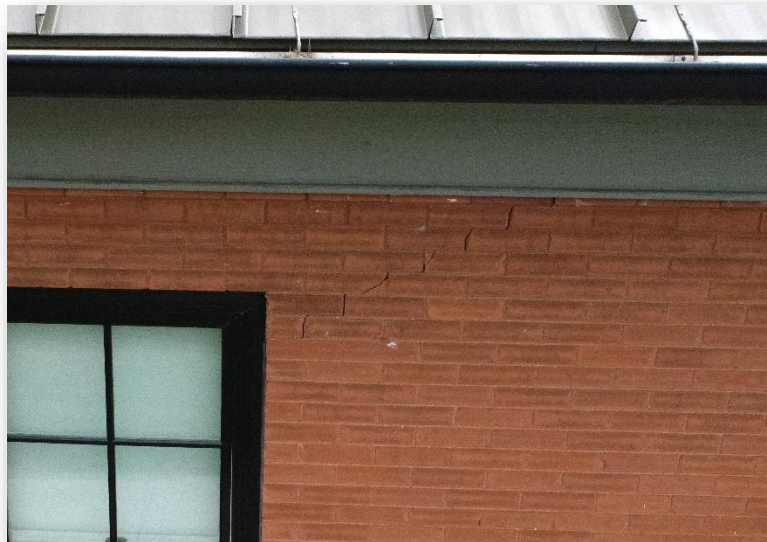
- **Movement Cracking:** Along the west wall and southwest corner there are areas of settlement that have caused movement cracking in the brick masonry. As one specific reason for the settlement has not been determined, it is most likely these cracks will continue to move slightly widening and shrinking as thermal changes occur over the seasons, or as road work or parking lot work is done in the future. We suggest the brick and mortar in the areas of movement cracking not be replaced as they are too rigid to accept this level of movement. These areas will be cleaned from previous sealant installation, routed to create a proper bonding surface, and a silicone sealant of matching color along with a sand surface broadcast will be installed to mimic the look of a masonry joint. This will conceal the installation of sealant and blend in with the surface of the building.

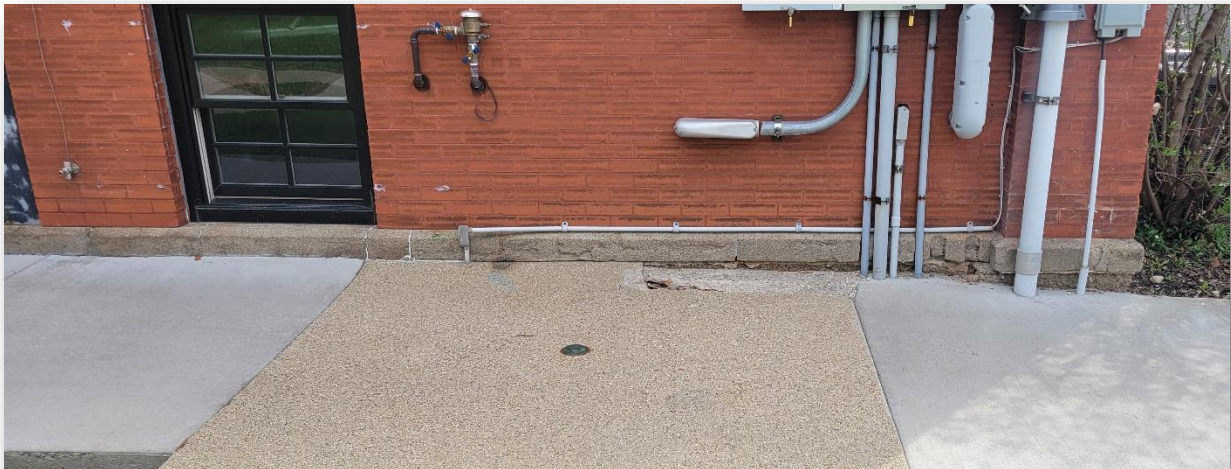
- **West Wall Curb Sealants and Concrete Replacement and Repair:** The concrete curb stone to sidewalk juncture along the west wall has experienced movement and deterioration over time. As these joints have opened they allow water to penetrate the foundation and water service vault, deteriorating the concrete surface. It is necessary to seal these areas to eliminate water intrusion. All open joints, cracks, and separations in the curbing will be routed and sealed with a silicone sealant broadcast with sand to mimic masonry. A cove seal will be repaired or installed between the curb and the sidewalk. The sidewalk joints will be caulked and sanded. The concrete area by the electrical connections will be patched and repaired and the surface will be removed and reinstalled. After concrete repair is completed the lid to the water access vault will have a polymer modified surface coating applied. This will mimic the look of concrete but will seal off this vault lid and not allow saturating water to percolate through the top of the vault.

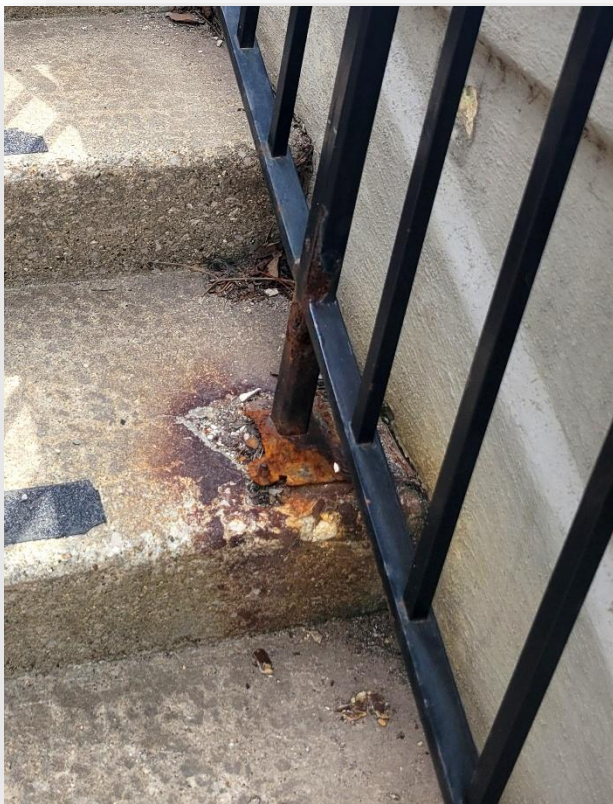
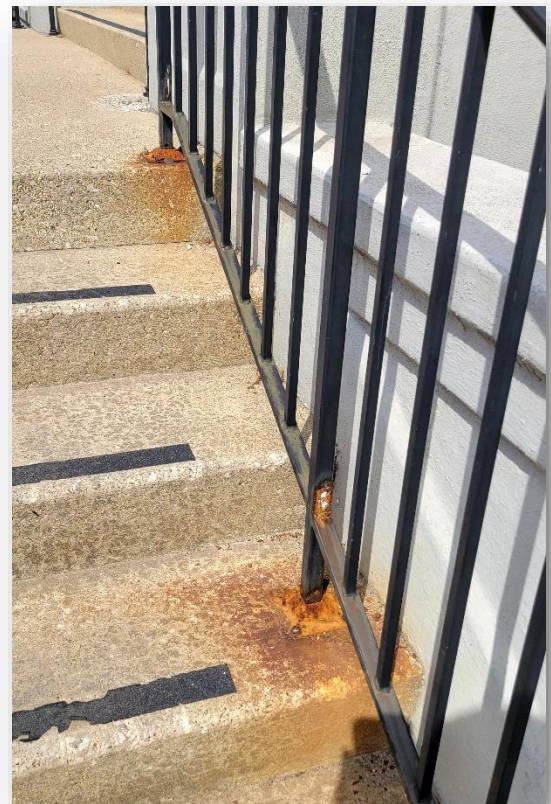
- **Main Entrance Handrail Repair and Reinstallation:** The existing handrail is beginning to rust and become unstable just above the anchoring base plates. Many base plates have rusted through and are no longer functioning to help keep stability in the rail. Currently, it is in a usable condition, but this repair is necessary sooner rather than later. Handrail sections will be removed one half at a time so all surfaces of the stair will still have at least one usable handrail. The handrails will be cleaned and repaired. The base plate will be cut off and a new stacked base plate will be installed with a modified hole pattern so when it is re-anchored the same holes are not utilized. After the repairs are completed the handrails will be reinstalled and the other section will be removed to facilitate the repairs.

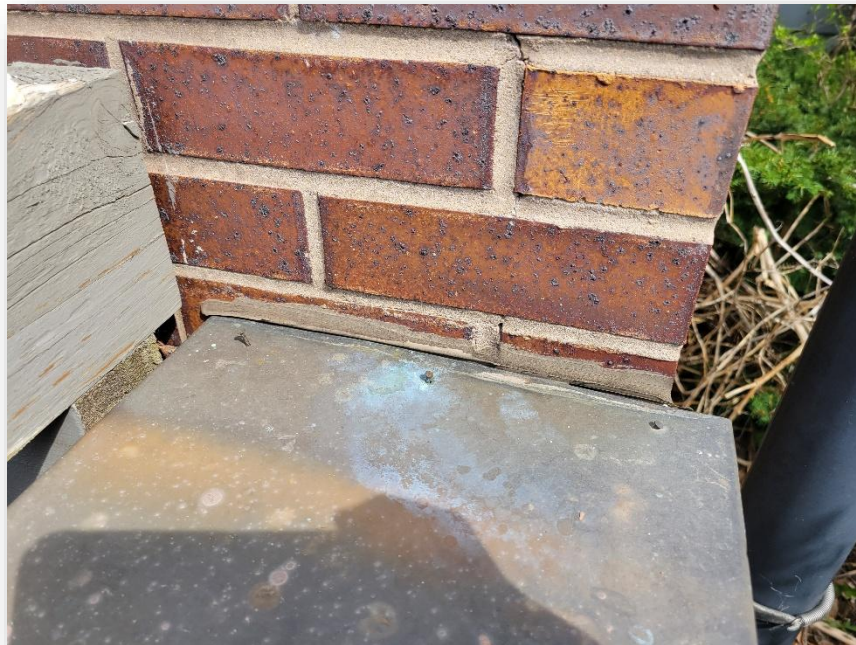
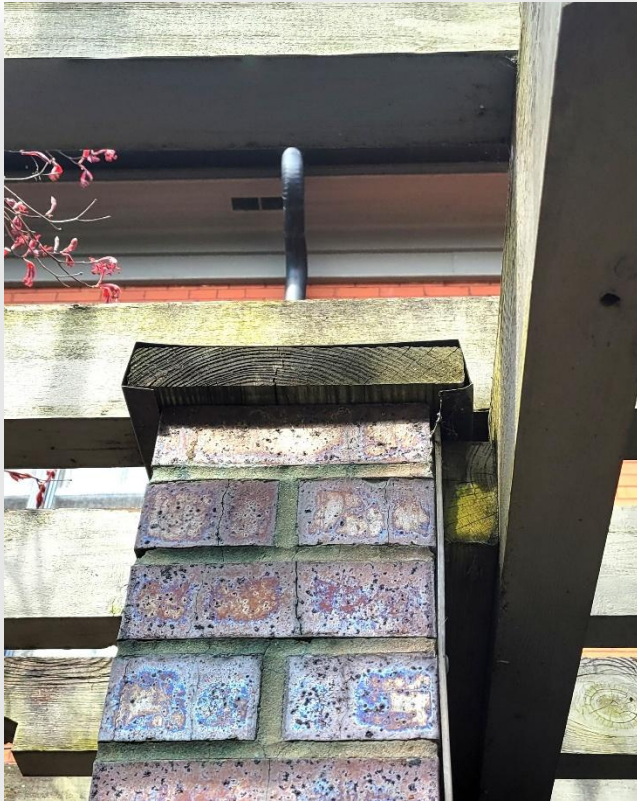
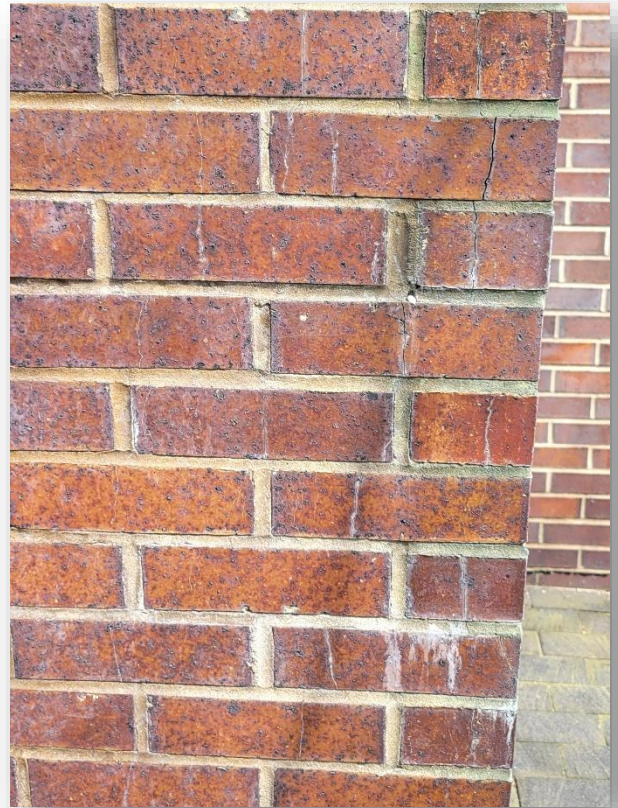
- **Flashing Caps at Patio Entrance:** The brick wing walls that create the entrance surround at the lower patio level of the new section of the library have an inadequate flashing design. The copper flashing wrapping the wall plate on the top of the wall has no drip edge to stop water from cascading around the plate and running down the surface of the brick. There are overlaps in seams that are not sealed and are no longer intact. This allows water to enter through the top of the flashing and access the inside of the unheated wing wall. As this brick has core holes it is very easy for water to move through the wall and pool. During freeze/thaw conditions this water expands and cracks the brick as can be seen in the attached photographs both wing walls have staining and leaching along with cracked sections of brick. The roof sections will be supported, the flashing and wall plate removed, and new plates will be installed with aluminum wrap and cap flashing with a taller face and drip ledge to prevent water from cascading down the face of the wall. If an adequate brick match can be procured broken and cracked bricks will be replaced. Due to the coloration and iron spot pattern in the brick an adequate match is highly unlikely. If a brick is not found an option to rout and seal the cracks with a sand broadcasted silicone will be discussed.

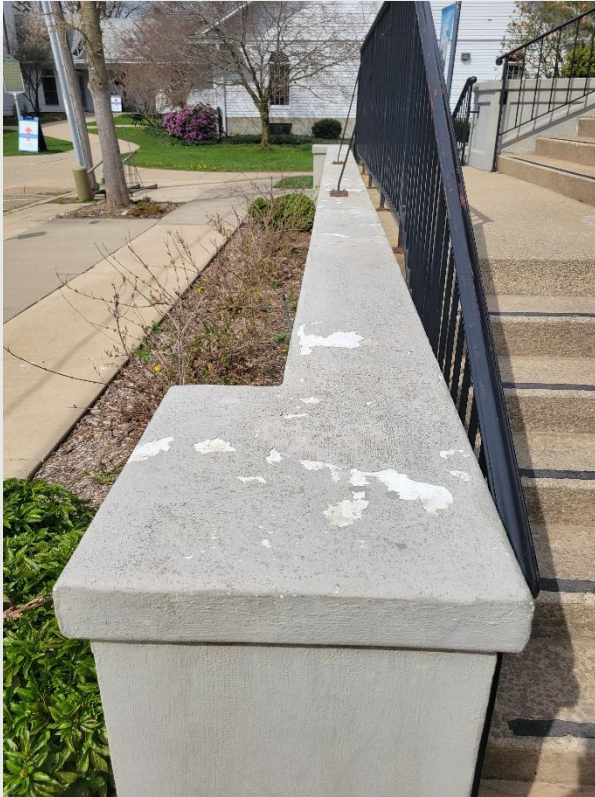
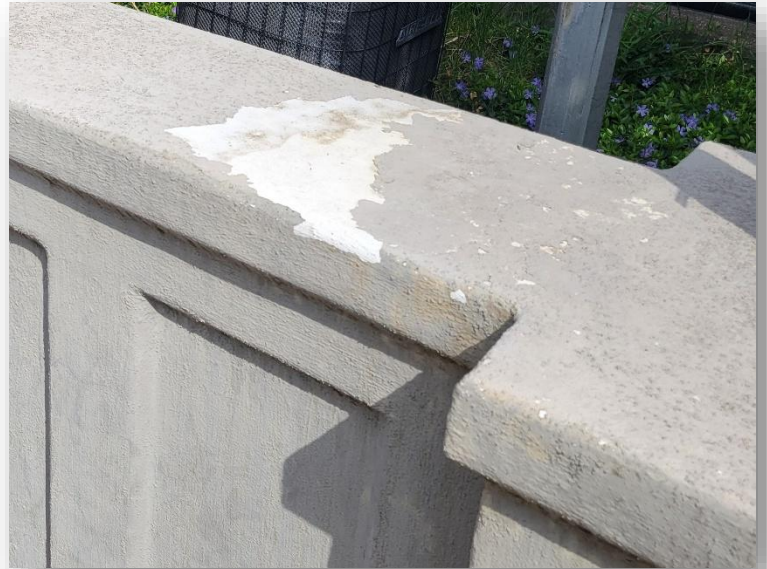
- **Main Entrance Site Wall Surface Coating:** The existing masonry slurry coat that has been applied to the main entrance site walls is debonding and flaking. Many areas have come loose, and this creates an aesthetically unpleasing surface. The surface coat was potentially applied to clean up the appearance of the wall but may also have been helping to reduce water intrusion and prolong the life. We suggest a heavy power washing and surface preparation take place and a new thin shelled masonry surface coating be applied.

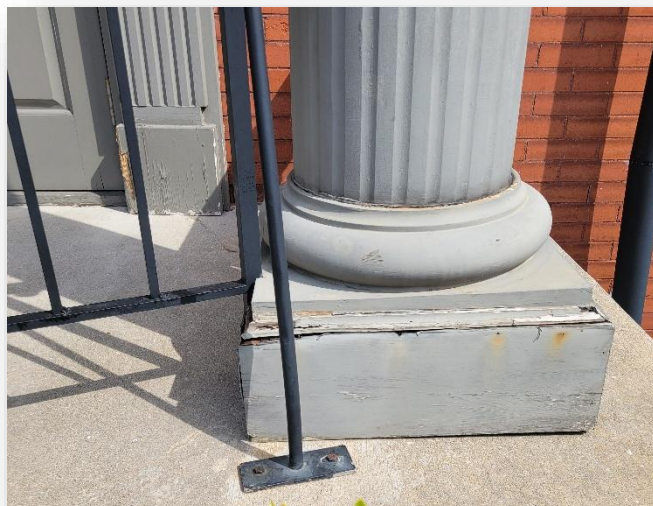
- **Main Entrance Column and Door Wood Repair:** At the main entrance to the library the wood wrapped column bases and entrance door surround trim are experiencing water intrusion and minor rotting. The bubbling and blistering paint allows water to access the wood and accelerate the deterioration. The column base trims are currently in need of replacement and most of the wood structure requires repair, cleaning, and repainting.

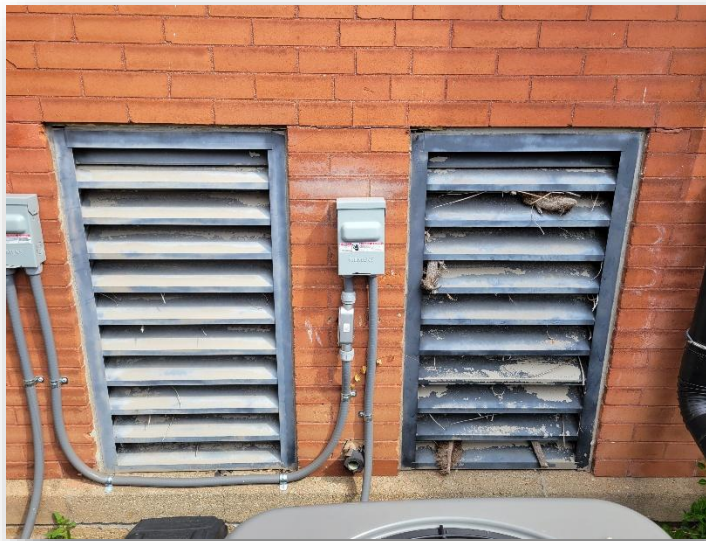
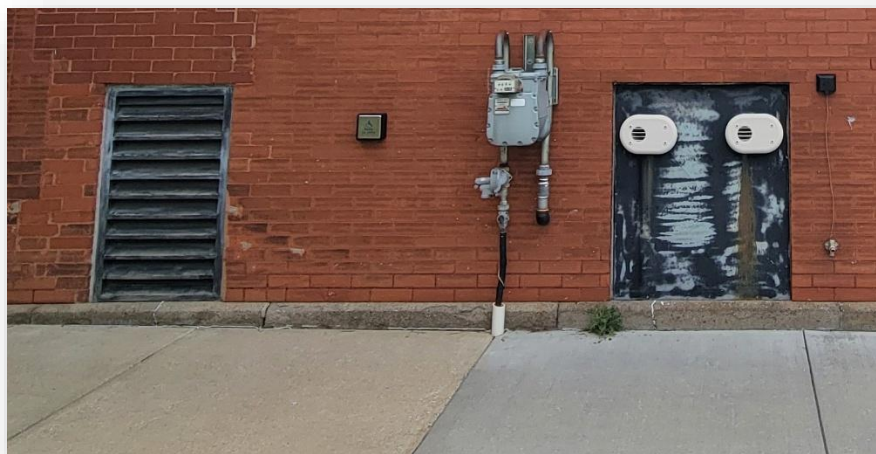
- **Vine Removal and Louver Repair:** On the southwest corner of the main entrance and the west wall the original structure has decorative metal louvers and window infills that require cleaning and painting along with the removal of vine growth. The vegetation that is causing the growth of the vines has been removed but the sections of vines that are embedded in the louvers are still attached. These will need to be cut out and removed so repair of the louvers can take place. The louvers will be water blasted to create an adequate bonding surface for new coats of primer and paint. The louvers will be primed and painted a matching color to the library entrance wood.

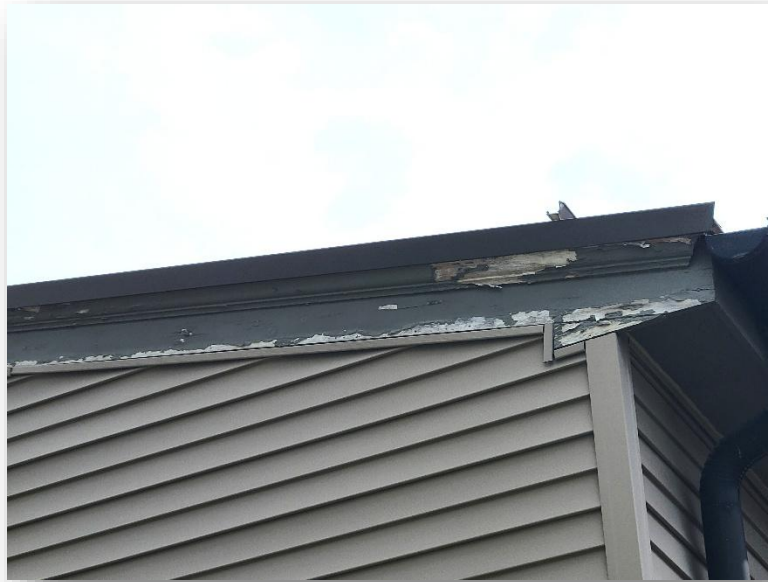
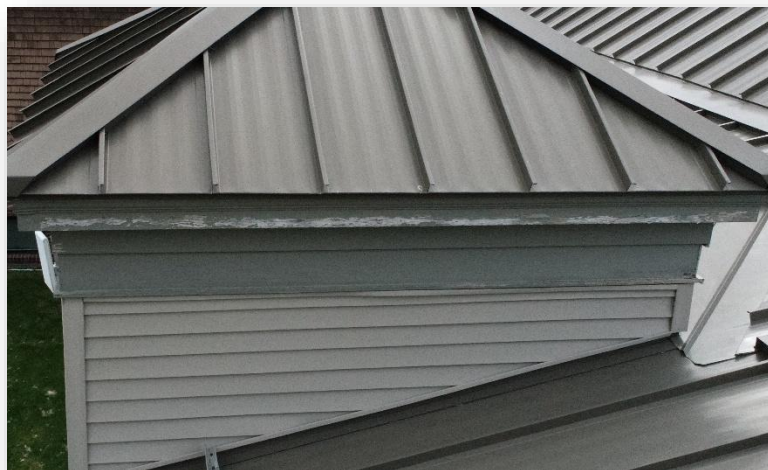
- **Wood Trim at West Entrance, Soffit and Fascia Repair on Original Building Additions:** All these wood trim sections have experienced deterioration in the paint layers over time. Many sections are bare wood and require a light sanding to close the surface, primer and two coats of paint. This will take place on the door surround of the west, all the soffit and fascia of the rear addition along with the gabled wood trim and siding to seal the surface of the wood and reduce the ability for water to infiltrate and rot these detailed **sections**.

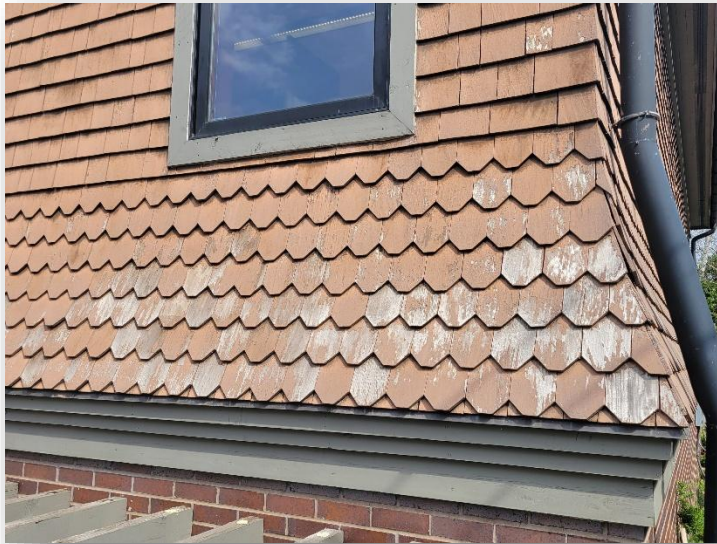
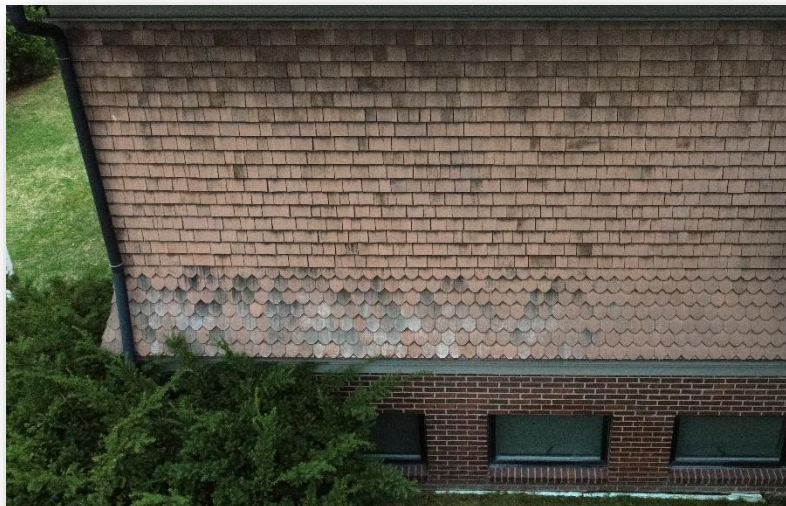
- **New Building Siding, Cleaning, and Repair:** The wooden fish scale siding on the newer building has greatly faded over time and many of the surfaces are completely losing their paint. A heavy power rinse will eliminate any de-bonded and flaking paint and create a surface adequate for bonding a new exterior paint. As this is a wood siding a breathable paint or colored stain will be utilized to allow the wood to expel moisture during very humid seasons.
